**DEPARTMENT OF TRANSPORTATION**

Contract #: 04-0120F4Cty: SF/ALA Rte: 80 PM: 13.2/13.9File #: 69.28**WELDING INSPECTION REPORT****Resident Engineer:** Siegenthaler, Peter**Address:** 333 Burma Road**City:** Oakland, CA 94607**Report No:** WIR-019774**Date Inspected:** 16-Jan-2011**Project Name:** SAS Superstructure**OSM Arrival Time:** 1500**Prime Contractor:** American Bridge/Fluor Enterprises, a JV**OSM Departure Time:** 300**Contractor:** Zhenhua Port Machinery Company, Ltd (ZPMC), Changxing Island **Location:** Shanghai, China**CWI Name:** See Below**CWI Present:** Yes No**Inspected CWI report:** Yes No N/A**Rod Oven in Use:** Yes No N/A**Electrode to specification:** Yes No N/A**Weld Procedures Followed:** Yes No N/A**Qualified Welders:** Yes No N/A**Verified Joint Fit-up:** Yes No N/A**Approved Drawings:** Yes No N/A**Approved WPS:** Yes No N/A**Delayed / Cancelled:** Yes No N/A**Bridge No:** 34-0006**Component:** OBG**Summary of Items Observed:**

Bay 14 (east line)

MT Inspection

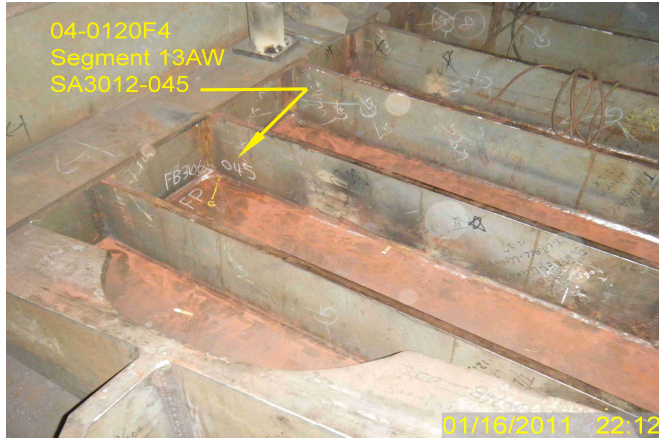
\* This QA inspector identified one location where Visual and MT indications have been noted, due to ZPMC not having labor personnel to grind this location on this date to defer from relevant and non-relevant indications. This weld area has been turned over to day shift personnel to have ZPMC grind this area that has been clearly marked.

The following digital picture illustrates the marking of SA3012-045 weld.
